# UNITED STATES COAST GUARD

INVESTIGATION INTO THE CIRCUMSTANCES  
SURROUNDING THE LOSS OF THE COMMERCIAL  
FISHING VESSEL

## BETH DEE BOB

O.N. 960023, 15 NM EAST OF MANASQUAN, N. J.,  
ON JANUARY 6, 1999, WITH THE  
LOSS OF FOUR LIVES

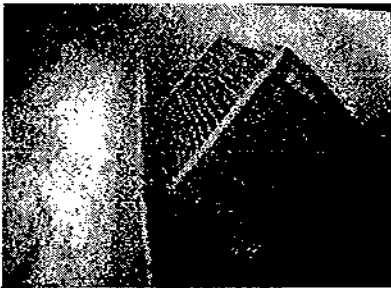
Videotape of the wreck shows cages double stacked in the forward clam wells so that the hatches had to have been open. It was not their practice to transport quahogs in the dredge and, in fact, there were no loose quahogs seen in the dredge in videotapes of the wreck. (371, exhibits 21, 22, 23)

Double stacked quahog cage

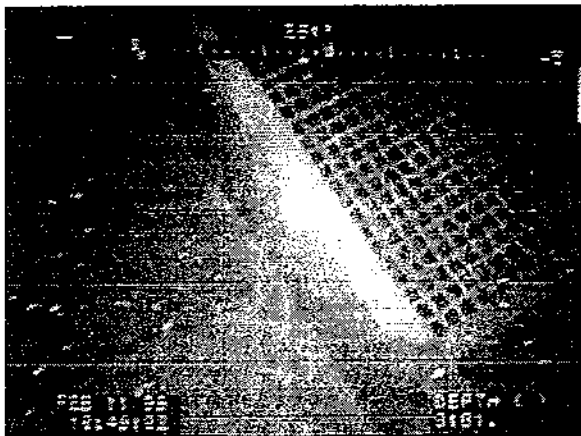
Toppled over double stacked cage

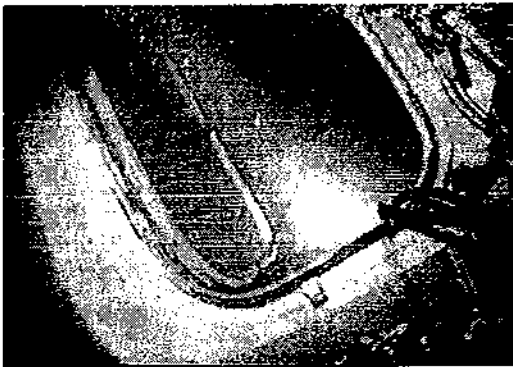
The port doghouse door is a full-sized door with four dogs and a gasketed surface that closes against a knife-edge (exhibit 23). The door sits on a standard height combing. The hinges are on the forward side of the door and the door opens outward. Just outside the door are clam cages in a deck rack.

Port doghouse door showing internal half-door

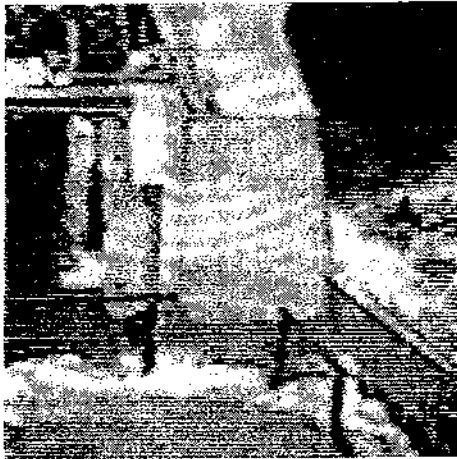
Former mate Brown testified that he usually had the watch on the way in and when the weather was rough, he always closed the port doghouse door. (600) He provided a videotape given to him by Bjornestad's wife (his sister-in-law) purported to be taken by Bjornestad on the last trip of 1998, a trip to use up the last of the year's allocation of tags. The number of available tags was less than a full load. (690) That videotape (exhibit 13) shows BETH DEE BOB with no cages on deck, with somewhat rough seas and water sloshing on deck. It clearly shows the port doghouse door open during that trip in.

Excerpt from Bjornestad video showing port doghouse door open while underway and with seas sloshing on deck with no cages on deck

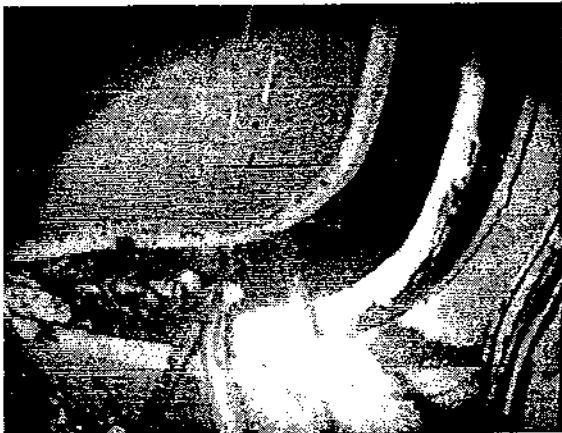
Harold Moyers was in the first dive team to go down on the second diving expedition on February 17, 1999 led by Robert Dellaury. He found the port doghouse door open 90 degrees. (1374) This is in keeping with the Coast Guard-directed Remote Operated Vessel dive videotape taken on February 11, 1999 (exhibit 22), which shows the door, open in minutes 17:41 and 19:01. The videotape shows quahogs inside the port doghouse.

Port doghouse door showing half-door opening in and clams piled inside

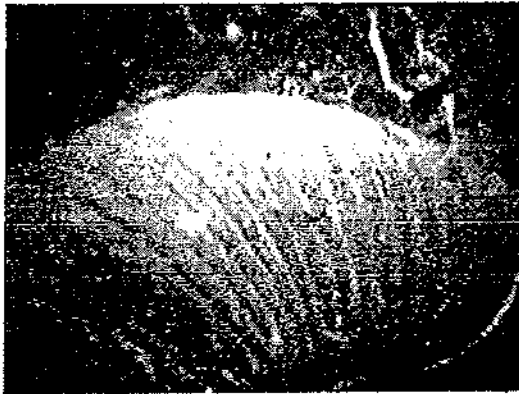
Corrugated ventilation ducting

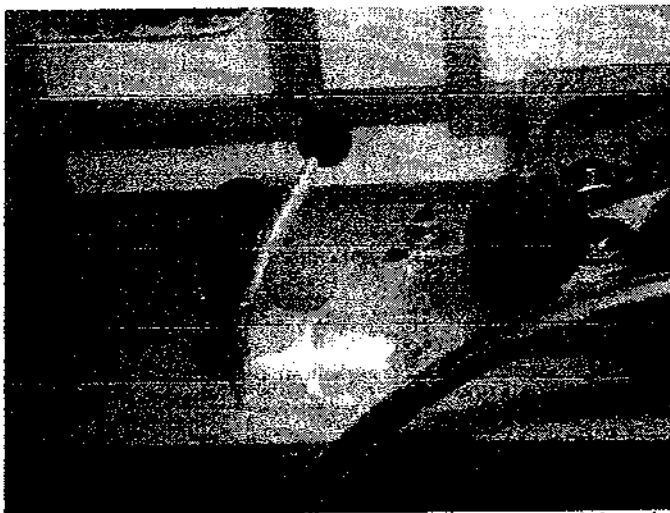
Photographs made on the 13 January dive were shown to former mates and captains who served on the vessel. The overwhelming conclusion was that BETH DEE BOB's propulsion engine was in forward gear at idle speed when she sank. Referring to the below photograph, Brown testified, "The black one is to put the engine in and out of gear, that's all the way forward so the engine would be in gear...and the red one is the throttle, which is pulled all the way back, its in the idle position." (607) He further testified that there were two engine control stations in the pilothouse. Brown also identified the lever shown in photographs of the wreck with the radio microphone hanging next to it as the clam pump throttle. He says it appears that the clam pump engine was either off or idling. (604)

Propulsion engine controls: black (left ) is clutch, red throttle

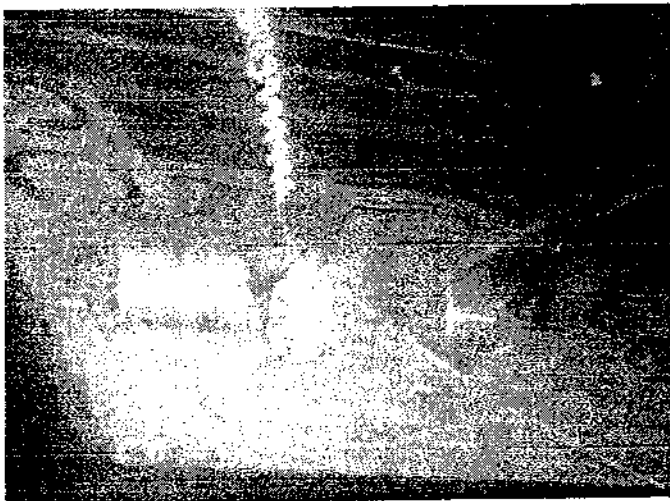
Clam pump engine throttle

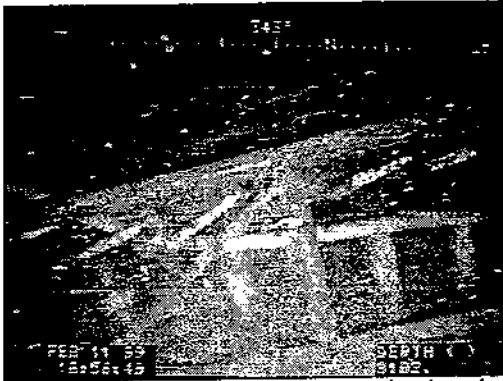
There was no pumping of the clam wells when the boat sank, and the indication is that there had not been any recent pumping out of the clam wells. Evidence from the wreck show the clam pump engine throttle was found in the idle position and the manifold valves for each clam hold were found closed. With the pump in neutral and the valves closed, it is certain that regardless of whether or not the pump engine was running, BETH DEE BOB was not de-watering when she sank. Since the bilge manifold system can be cross-connected to the clam pump, the engine room was not being pumped through the clam pump.

Clam well manifold; all valves are in closed position

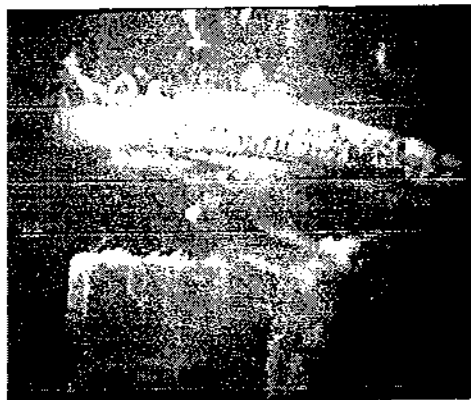
The port spool piece and valve were found in tact and closed watertight. The starboard side clam pump suction sea valve was found in the open position, however the clam pump, the pump engine and discharge piping were all found intact. The seachest and suction pipe outboard of the valve could not be examined below the engine room deck plates, however, it is unlikely that this small section of unexamined pipe was breached. No equipment failure appears to have contributed to this tragedy.

Starboard side clam pump sea suction valve showing stem in open position

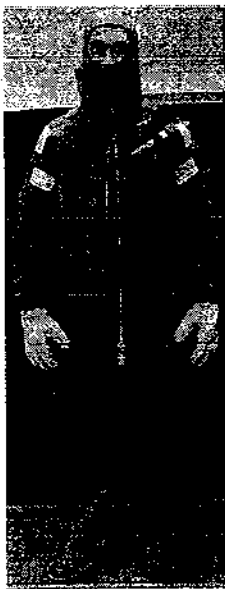
46 CFR Table 28.110 required BETH DEE BOB to have survival suits for each member of the crew. The 1998 Condition and Valuation Survey shows that they were aboard, were stowed properly, and were in good condition. It is not unreasonable to assume that none of BETH DEE BOB's crew was wearing survival suits at the time of the sinking.

Survival suit
